### **BT PoE LED Stream Interface**

#### Introduction

The LED stream feature supports IEEE 802.3bt PoE port status LEDs for products based on the Microchip PD69200, PD69210 or PD69220 PoE controllers. The LED stream is a serial bit stream between the PoE Controller, dedicated circuit, and the LED, as shown in the following figure.

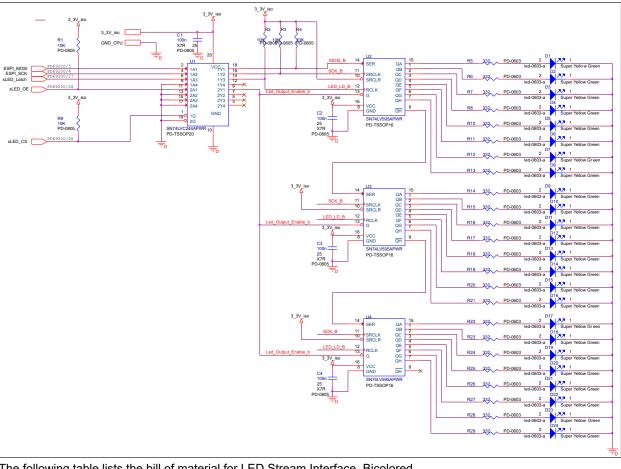
Figure 3-1. Bicolored LED Stream Interface with PD692x0

The following table lists the bill of material for LED Stream Interface, Bicolored.
